Inspection Report

Permit Number:	C0070012
Inspection Type:	PARTIAL
Inspection Date:	Monday, July 31, 2006
Start Date/Time:	7/31/2006 10:00:00 AM
End Date/Time:	7/31/2006 12:00:00 PM
Last Inspection:	Friday, June 30, 2006

Permittee: **NEVADA ELECTRIC INVESTMENT CO**

Site: **WELLINGTON PREPARATION PLANT**

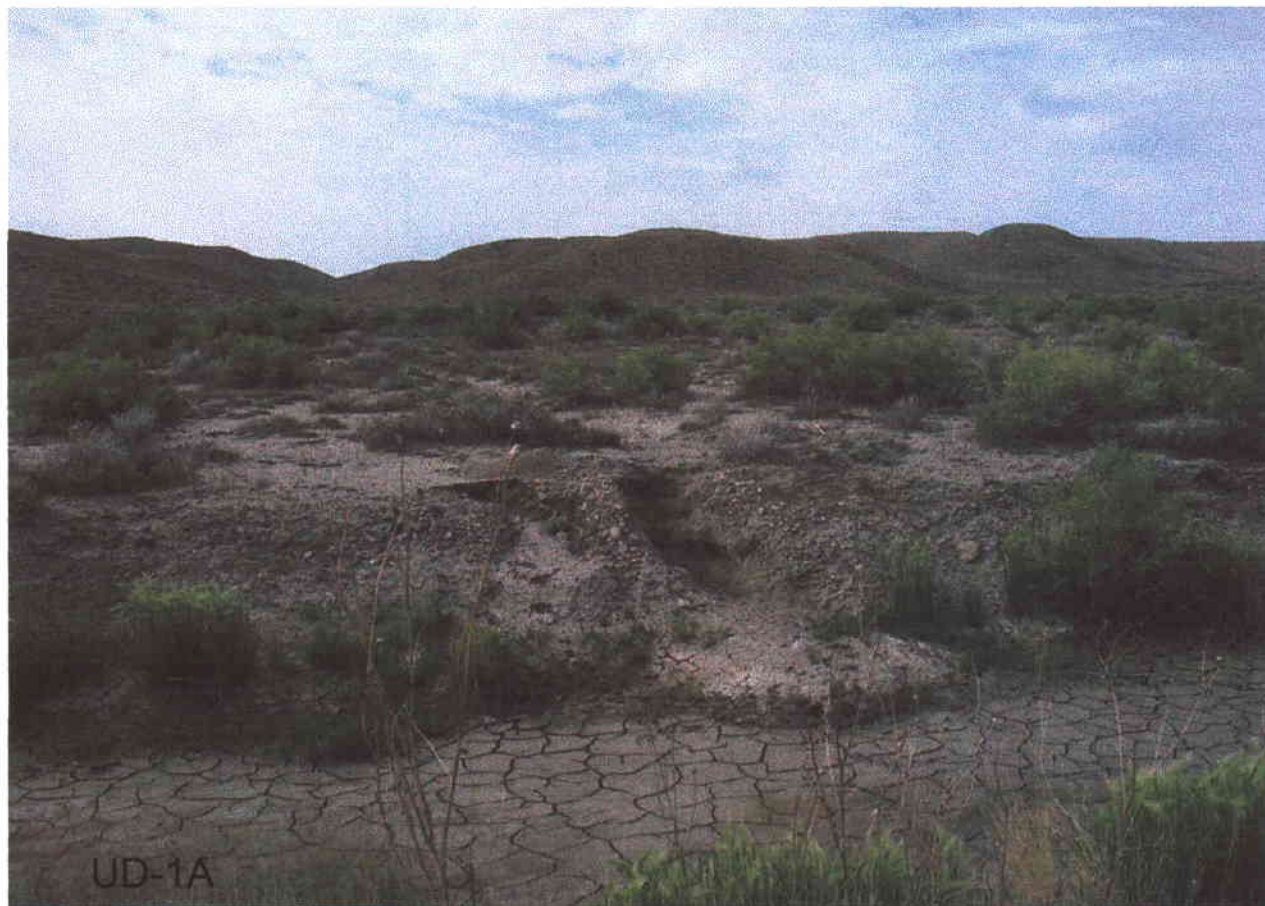
Ditch UD-1A and UD-1 are shown on Plate F9-177 sheet 1 of 2. Ditch maintenance according to design is required by R645-301-732.300 and R645-301-742.310 et seq and R645-301-742.330 et seq. The Wellington Preparation is due for ditch maintenance at UD-1A and UD-1. In several locations along the east end of ditch UD-1A and UD-1 erosion has created rills on the ditch bank and filled the ditch with sediment. In particular, one accumulation of sediment in ditch UD-1 has ponded water. Mr. Collins indicated that these sediment accumulations will be cleaned out. Mr. Collins is under the impression that it is not necessary to repair the eroded side of the ditch. He indicated that a previous Division inspector, released him from that responsibility. Photographs were taken of the eroded ditch.

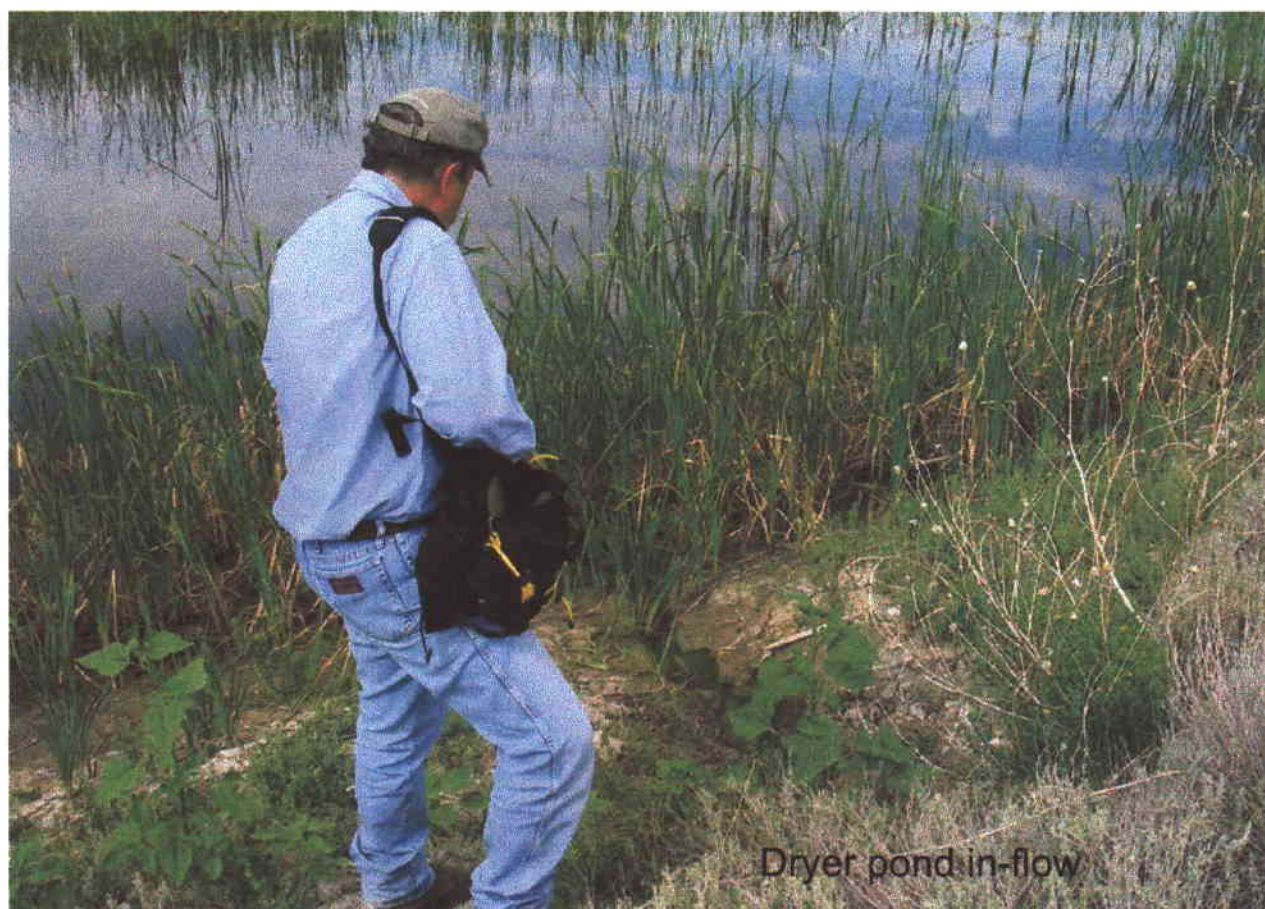
The Dryer pond was receiving water at a rate of 1 - 2 gpm. The water was cold, estimated temperature of 65 F. The auxiliary pond held water as well. The slurry pipeline road pond was dry. Photos were taken of the ponds.
